Project No. T322-25

PERFORMANCE TEST REPORT

**ANSI/SPRI/FM 4435/ES-1
TEST RE-2**

**TALONLOCK DRIP EDGE
(8" FACE X 0.040" ALUMINUM)**

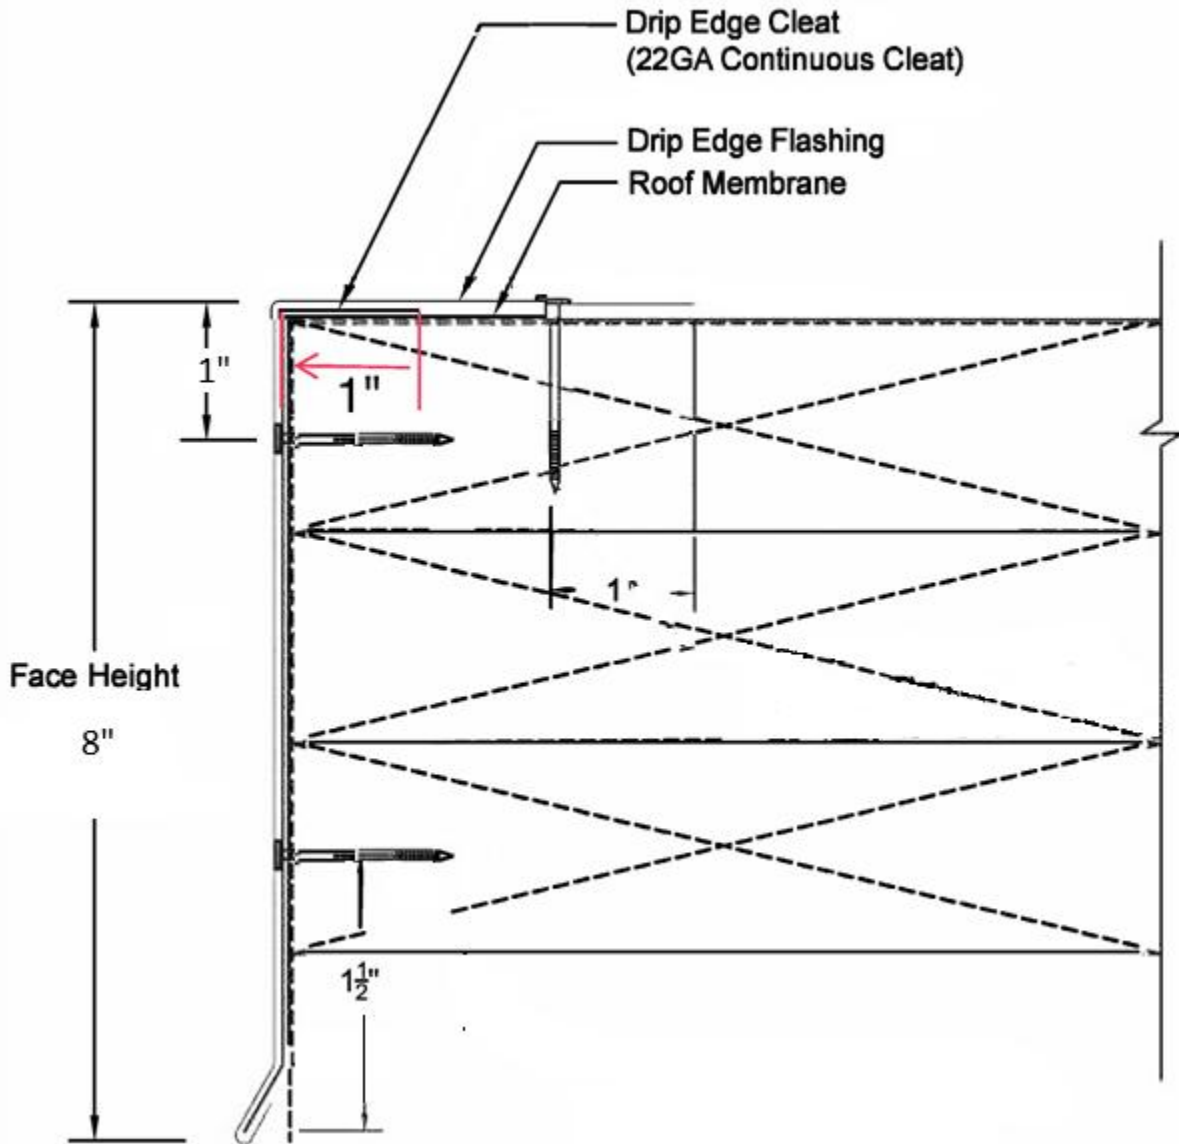
ASSEMBLY DETAIL

The mock- up consisted of a 0.040" Aluminum Cover with that was fitted on to a 22 ga Steel Continuous Cleat that was attached to wood blocking as shown on the attached drawings.

- Notes:
- Cleat and Cover was attached to No.2 Douglas Fir Wood Blocking With #10-13 X 1-1/2" GP Pancake Head Fasteners located at 12" o.c.
 - Roof Membrane not used in testing assembly.
