PERFORMANCE TEST REPORT

ANSI/SPRI/FM 4435/ES-1  
TEST RE-2

TALONLOCK DRIP EDGE  
(8" FACE X 24 GA STEEL)

METALWYZE  
106 PIERCES ROAD  
NEWBURGH, NY 12550

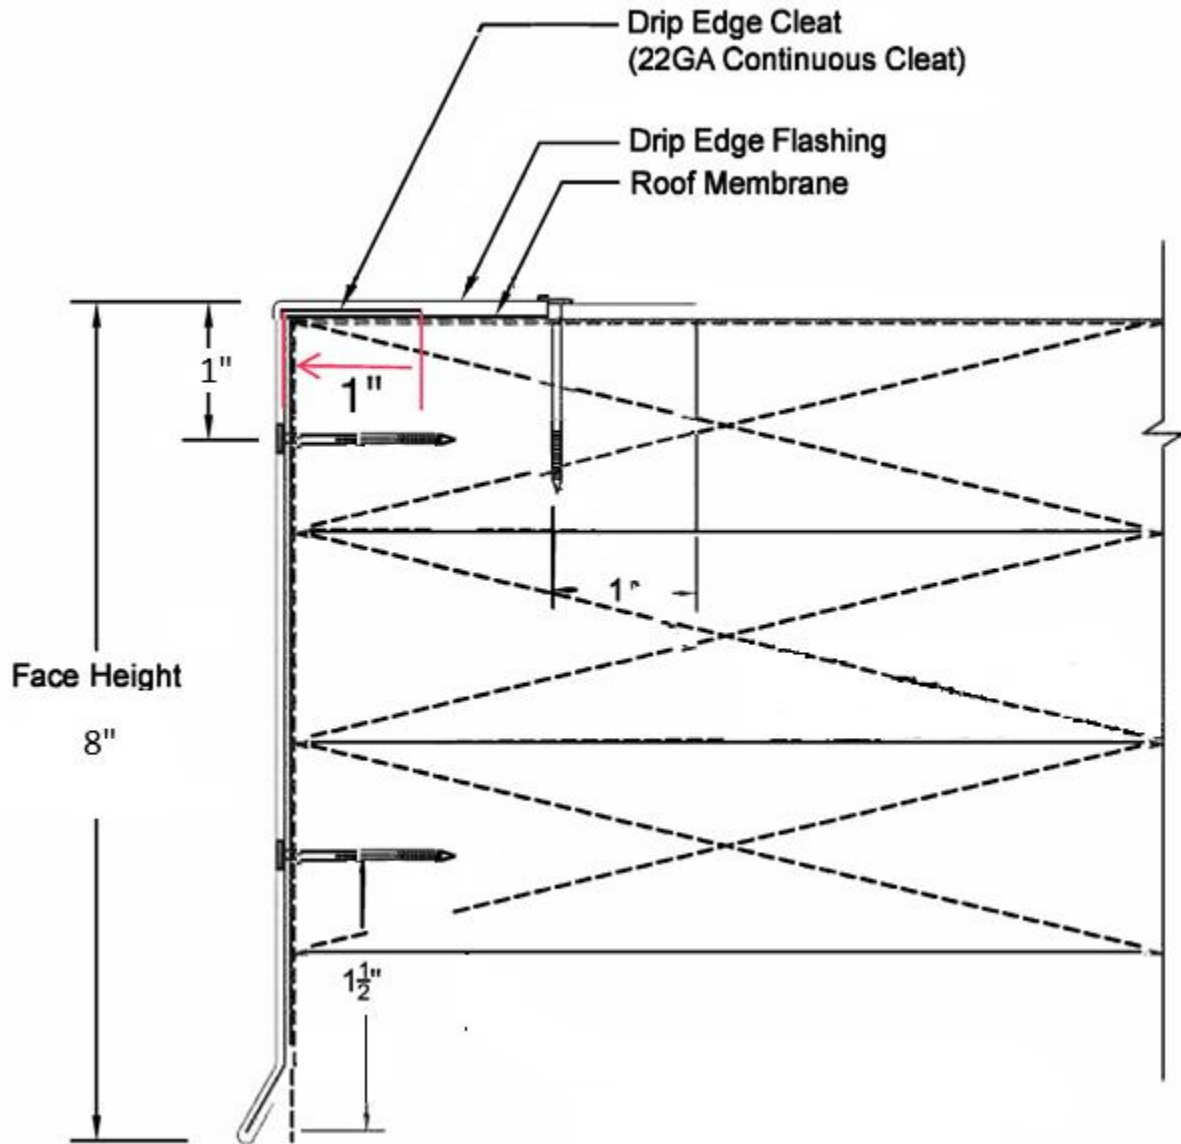
### ASSEMBLY DETAIL

- Notes:
- Cleat and Cover was attached to No.2 Douglas Fir Wood Blocking With #10-13 X 1-1/2" GP Pancake Head Fasteners located at 12" o.c.
  - Roof Membrane not used in testing assembly.

The mock-up consisted of a 24 ga Steel Cover with that was fitted on to a 22 ga Steel Continuous Cleat that was attached to wood blocking as shown on the attached drawings.
