PERFORMANCE TEST REPORT

ANSI/SPRI/FM 4435/ES-1
TEST RE-2

TALONLOCK GRAVEL STOP
(8" FACE X 24 GA STEEL)

METALWYZE
106 PIERCES ROAD
NEWBURGH, NY 12550

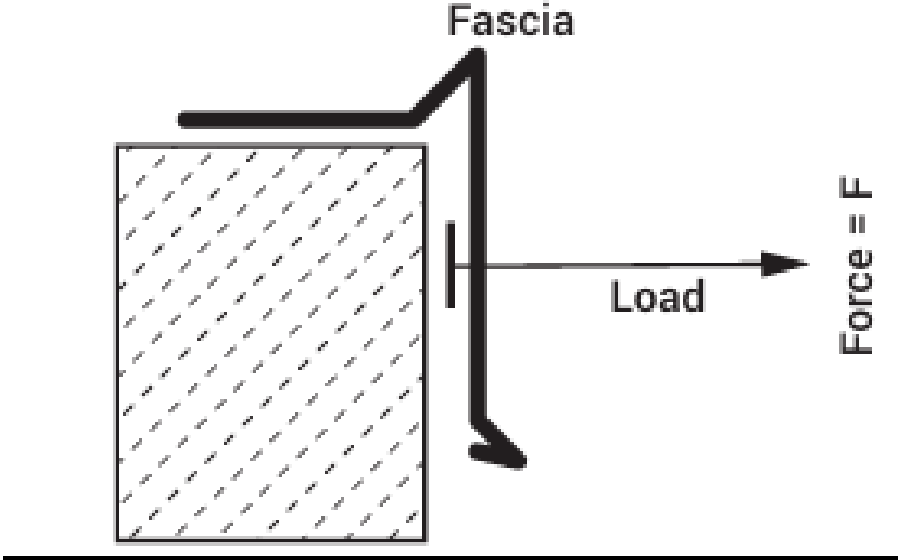
TEST DETAIL

The test procedure was per ANSI/SPRI/FM 4435/ES-1, 2022, Test RE-2 "Test Method for Edge Systems Used with Low Slope Roofing Systems" and as provided herein. Controlled loading devices provided face loadings. Loading was applied uniformly on 12" centers to the front face of the specimen. The load was applied on parallel horizontal centerline of the surface tested in an outward direction. Between incremental loads, the loading was reduced to zero until the specimen stabilized or a recovery period of not more than 5 minutes. The load procedure was continued until failure or the desired load was achieved

In attempt to reach the next loading increment, the cover disengaged from the cleat.

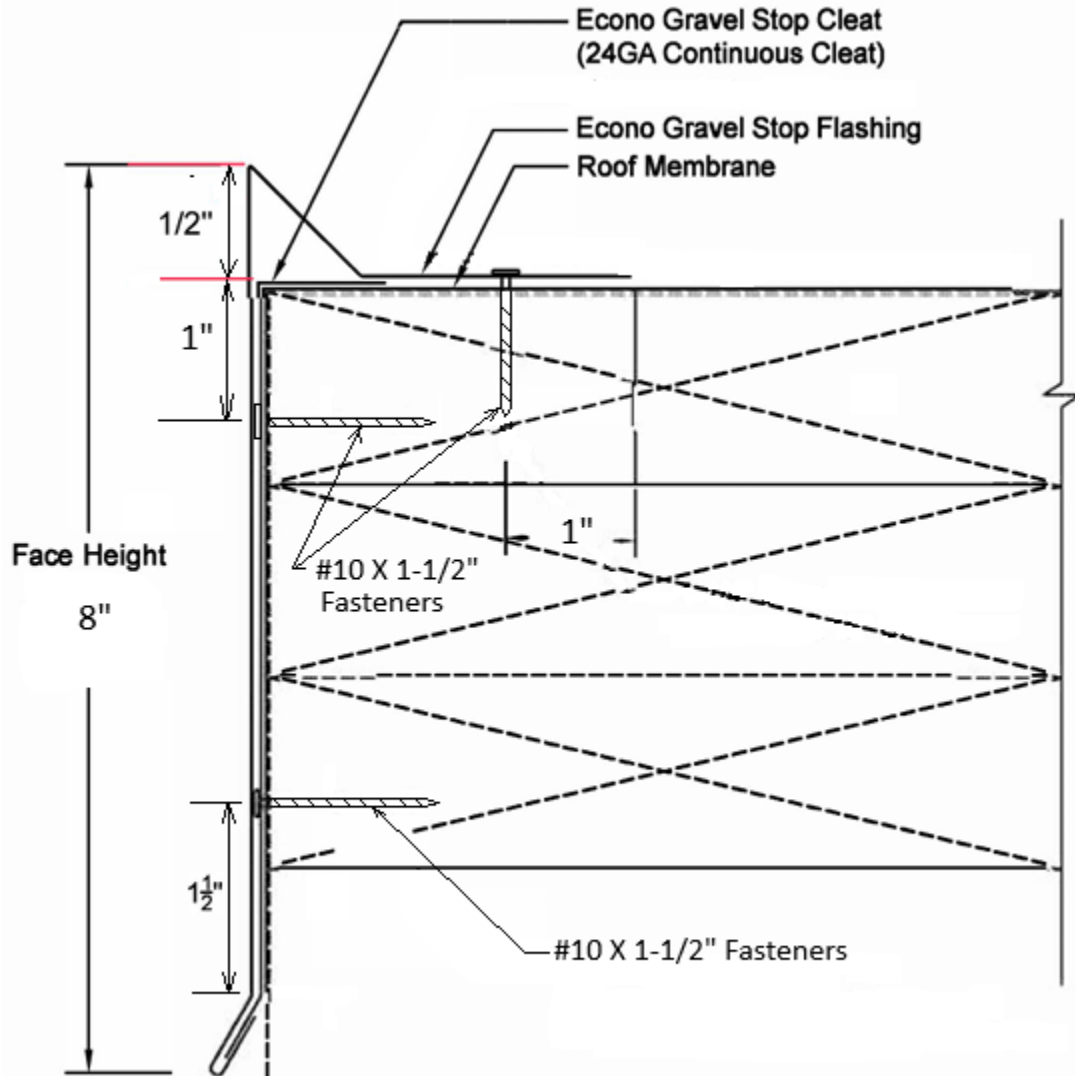
ASSEMBLY DETAIL

- Notes:
- Cleat and Cover was attached to No.2 Douglas Fir Wood Blocking With #10-13 X 1-1/2" GP SS Pancake Head Fasteners located at 12" o.c.
 - Roof Membrane not used in testing.

The mock- up consisted of a 24 ga Steel Cover with that was fitted on to a 24 ga Steel Continuous Cleat that was attached to wood blocking as shown on the attached drawings.

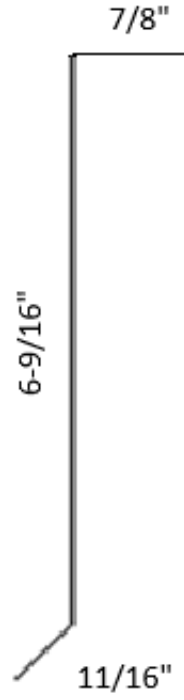
CLEAT

TalonLock Gravel Stop
- 8" Face X 24 ga Steel Cover (0.025" measured thickness)
- 24 ga Steel Continuous Cleat (0.025" measured thickness)
